Navajo Abandoned Uranium Mine

Site Screen Report

Melvin Benally No. 3 AUM Site

Weston Solutions, Inc.

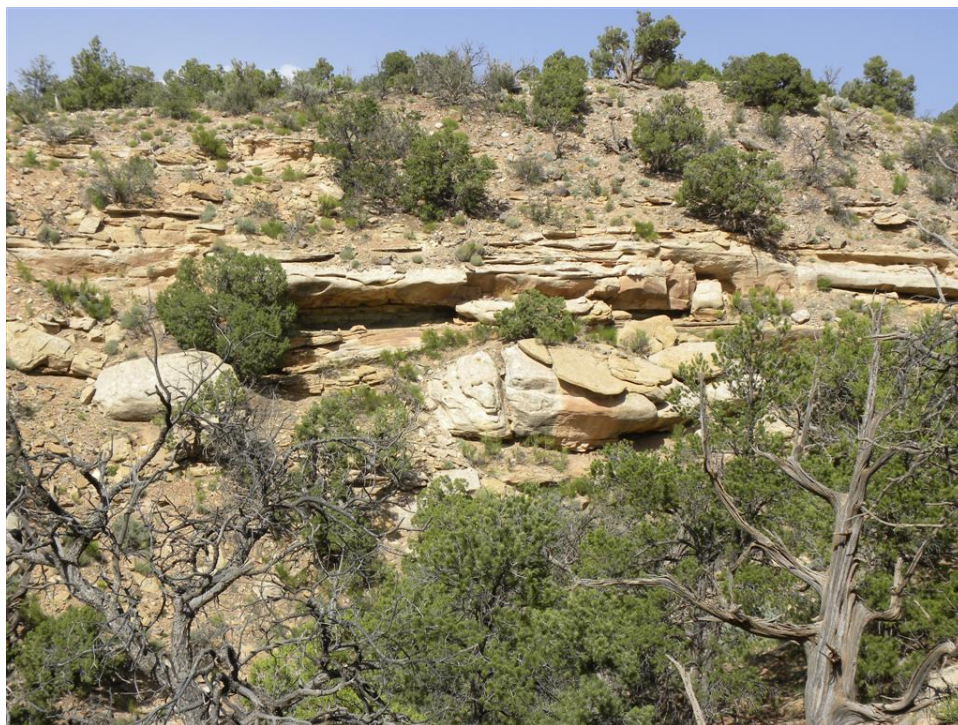
Photo 1. Melvin Benally No. 3 site

Various mining debris, metal cans, etc.
